## Concrete repairs Zuetina Jetty, Libya

Built originally in 1968 by an US contractor, the northwest breakwater and jetty at the Terminal of Zueitina Oil Company (ZOC) were up for repairs in 2007. The concrete piles of the north jetty and the west breakwater as well as the capping beams and the parapet wall showed serious signs of deterioration and severe cracking. In order to ensure the future safely operations of the jetty proper repairs had to be conducted. The contract was awarded to Interbeton Libya, branch office of BAM International bv.

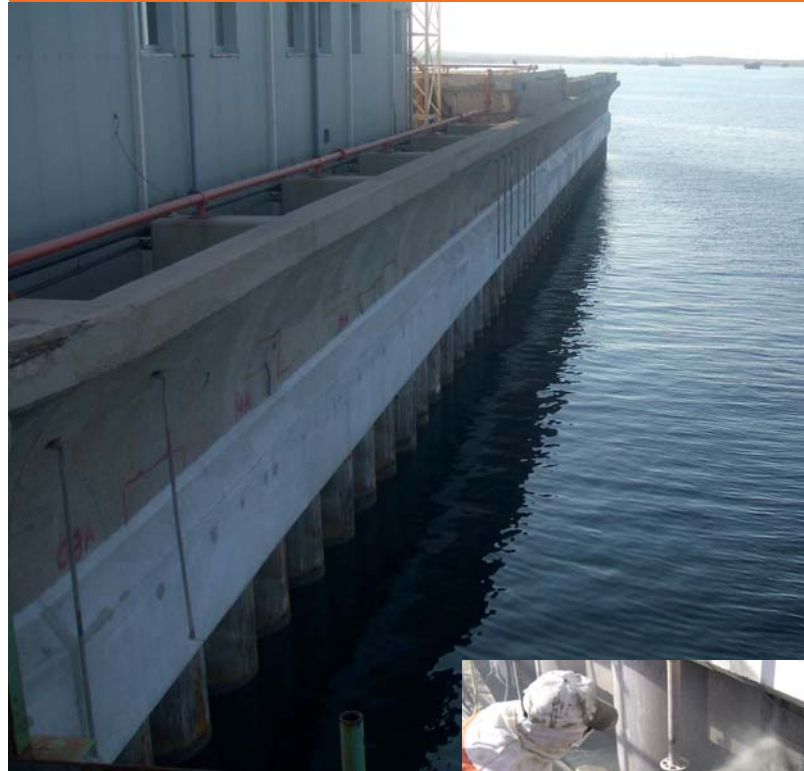
Shotcreting the piles

The demolition of the existing, deteriorated concrete was done by means of a high-pressure hydroblasting machine (2500 Bar) and the pile repairs were executed by means of shotcreting.

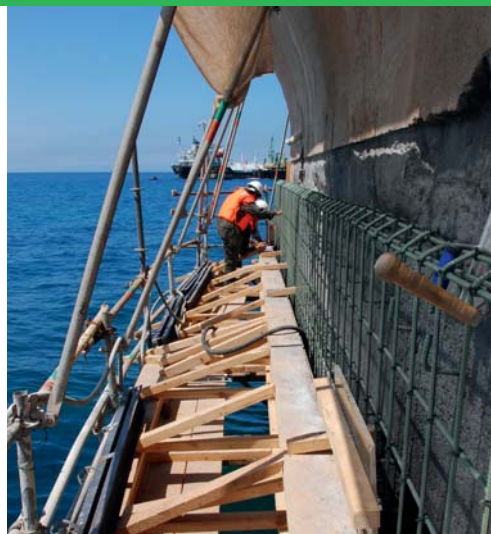
Hanging platform  
for jacketing the tie beam

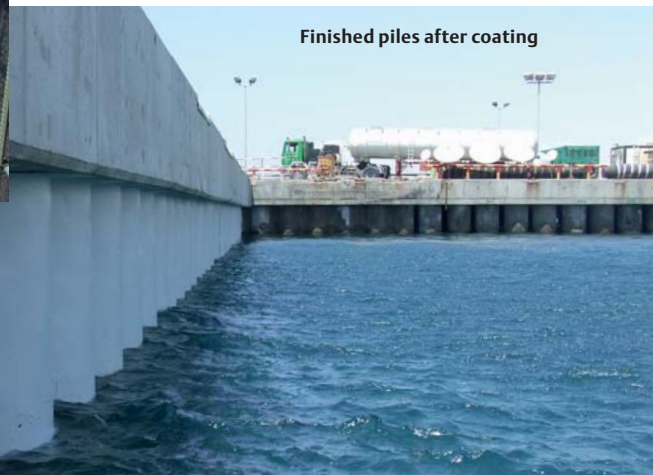
Finished piles after coating

- Group 1 - Preventive maintenance by painting the exterior of the piles from the waterline up to connection of the tie-beam.
- Group 2 - Small patch repairs by means of shotcreting.
- Group 3 - Complete structural repair by filling hollow piles with structural concrete and shotcreting of the pile surface.
